GZA
GeoEnvironmental, Inc.

Re: Task 3 Dam Assessment - Final Report
Project #0-381
SRP Coronado Generating Station Evaporation Pond Dam
Apache County, Arizona

EXECUTIVE SUMMARY

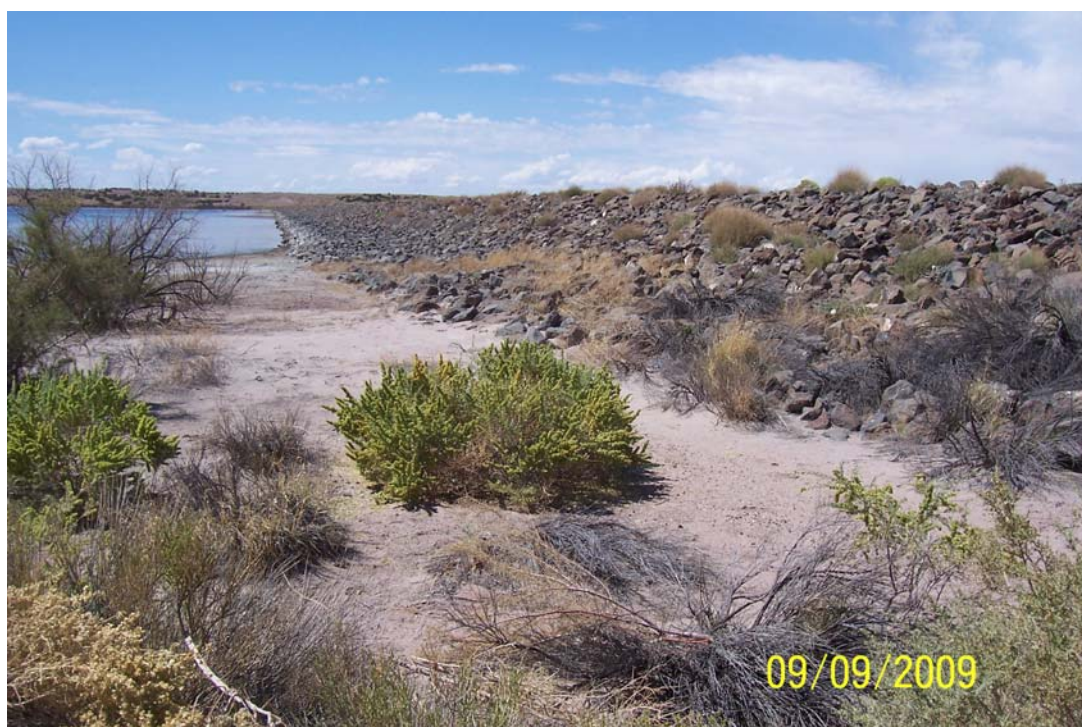
Photo 2: Overview of upstream slope of dam from right abutment contact. Note moderate brush growth on riprap slope.

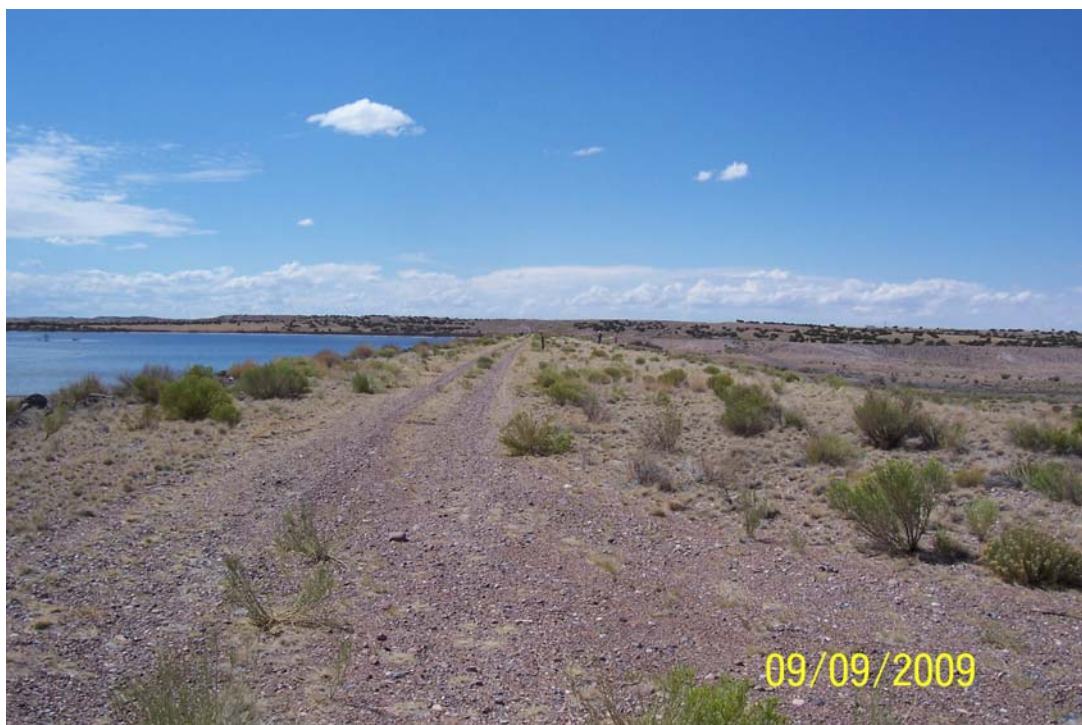
Photo 4: View along top of dam from right abutment area. Note grass and brush vegetative cover and minor rutting from vehicular traffic.

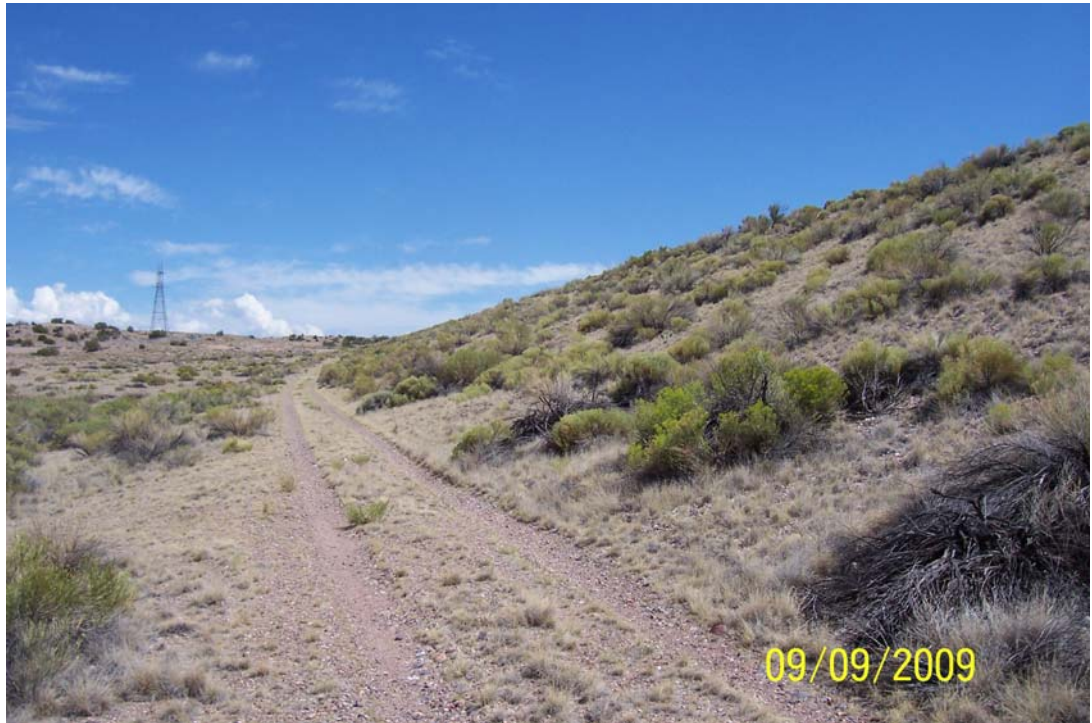
Photo 7: View along downstream slope of dam looking towards right abutment, taken from access road along downstream toe. Note minor rutting of access road.

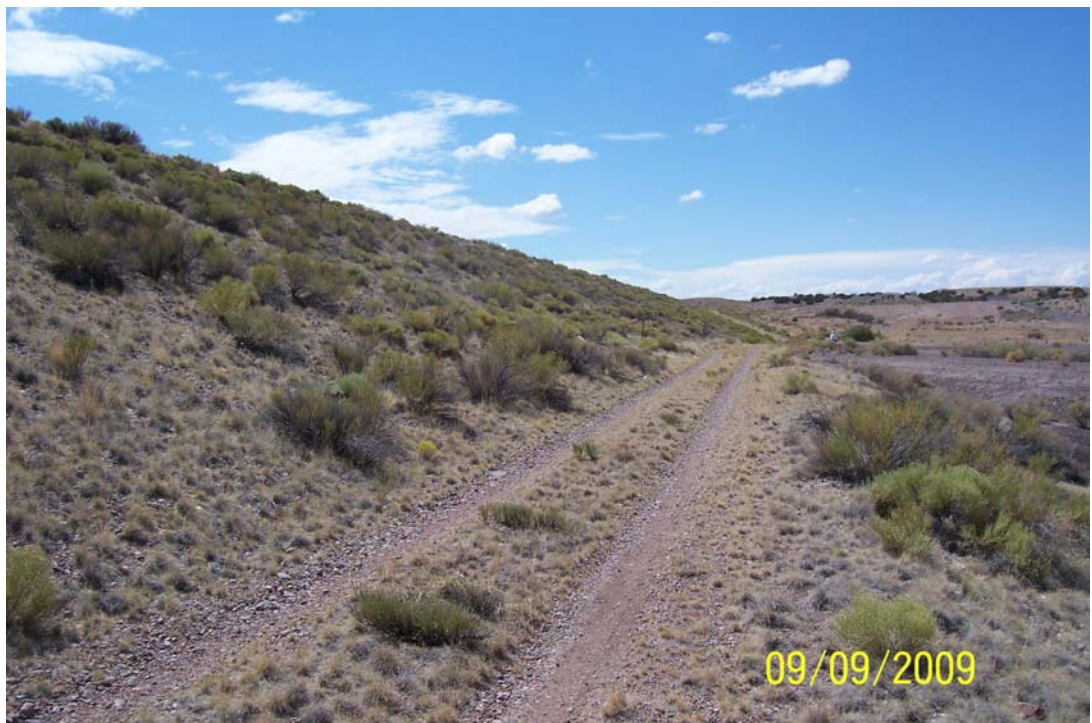
Photo 8: View along downstream slope of dam looking towards left abutment, taken from access road along downstream toe. Note minor rutting of access road

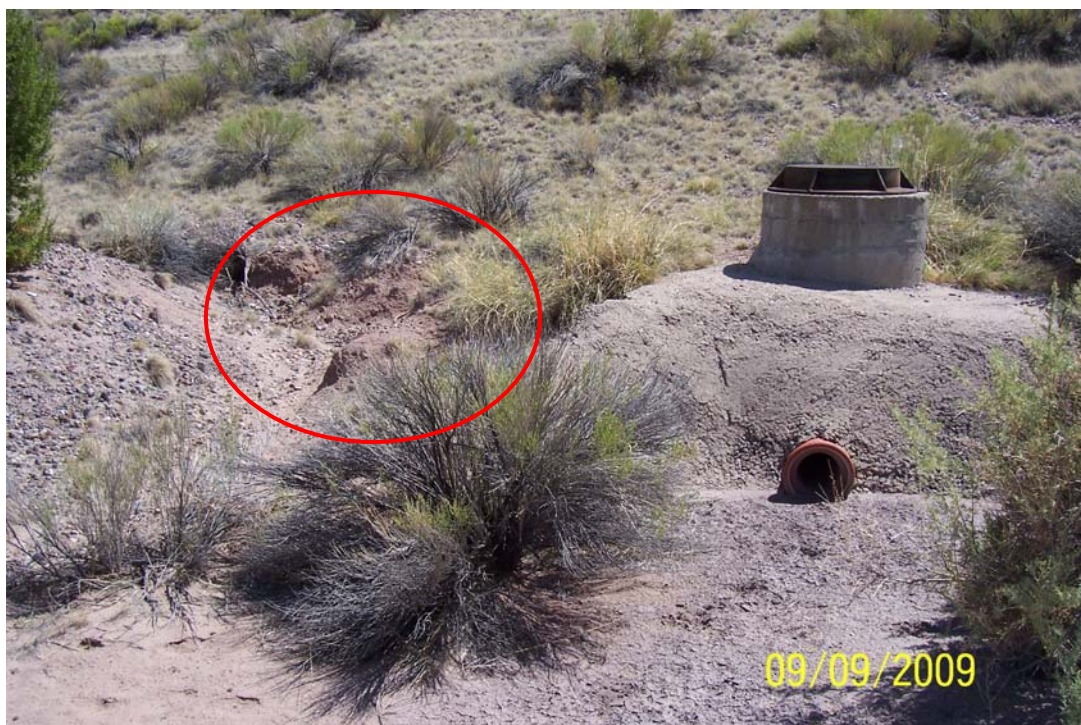
Photo 10: View of right toe drain manhole from downstream dry channel. Note minor erosion adjacent to concrete cover (circled).

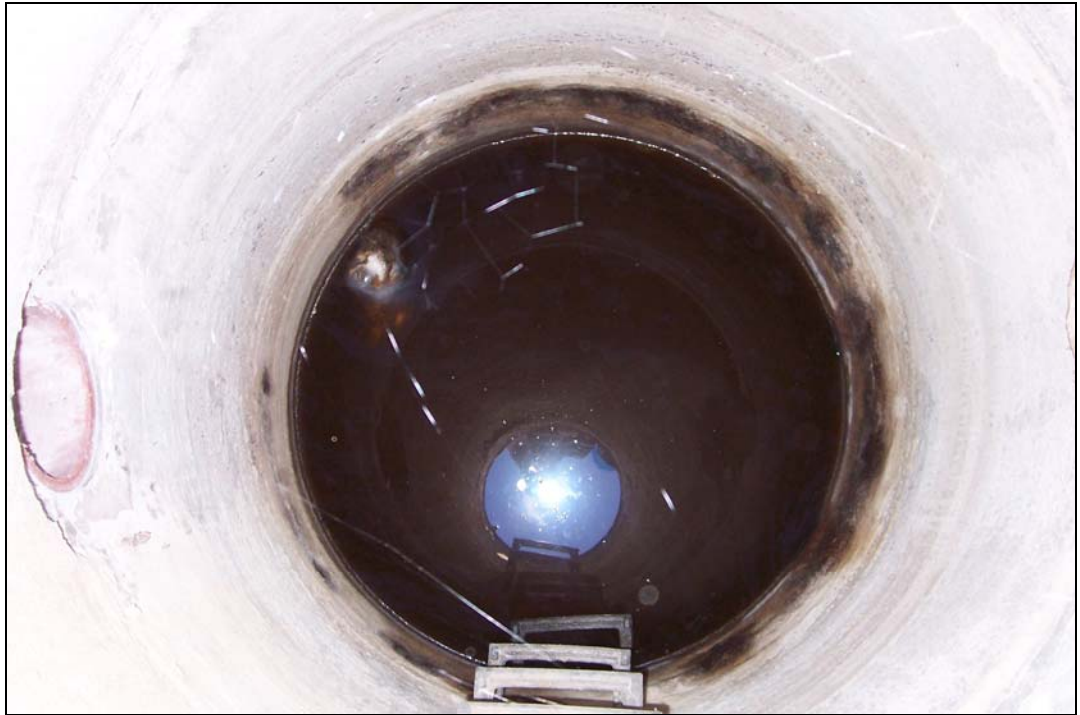
Photo 11: View inside right toe drain manhole. Note standing water at bottom of manhole, and dry inlet and outlet pipes.

3. Conduct a camera survey of the interior of the left and right toe drain seepage collection pipes to evaluate the condition of the pipe section alignment, joints, and any potential blockage.

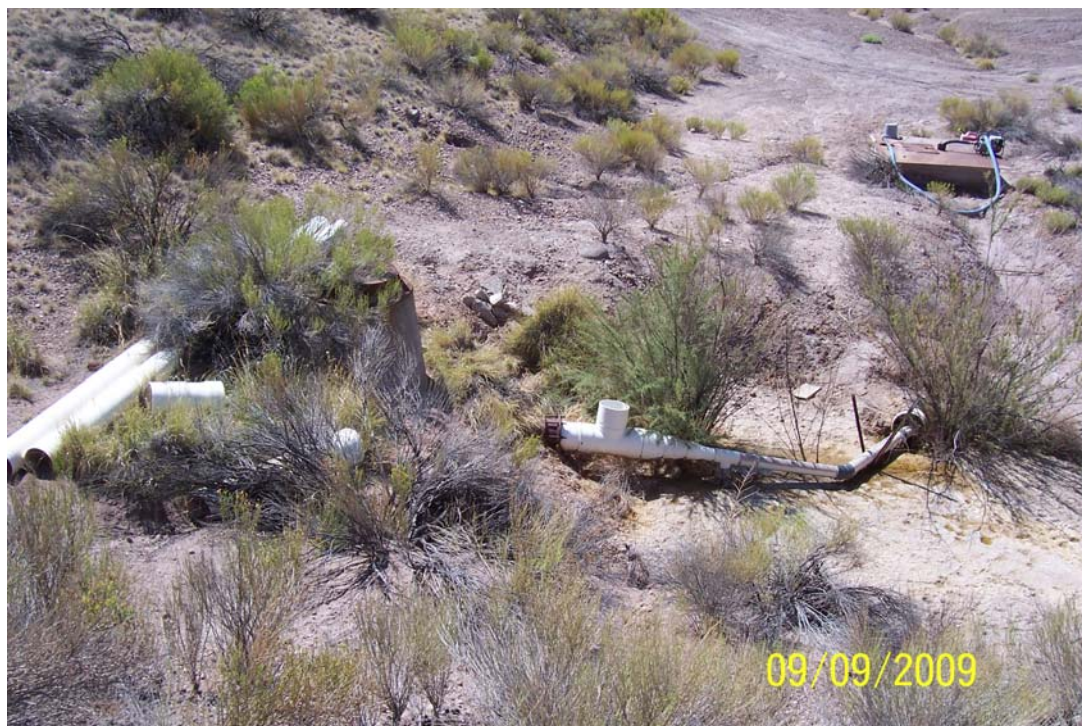
Photo 13: Overview of left toe drain collection system. Toe drain manhole (left) is connected by PVC piping to sump well (right). Note wet soil around PVC pipe.

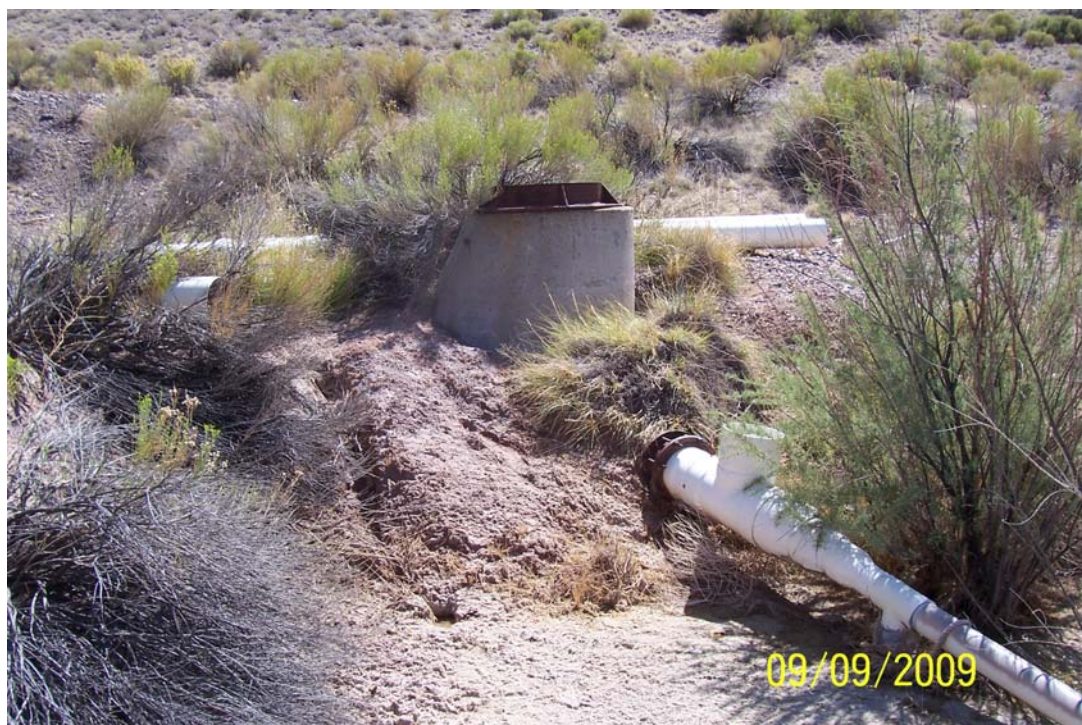
Photo 14: View of left toe drain manhole from downstream. Note heavy brush and vegetative cover around manhole.

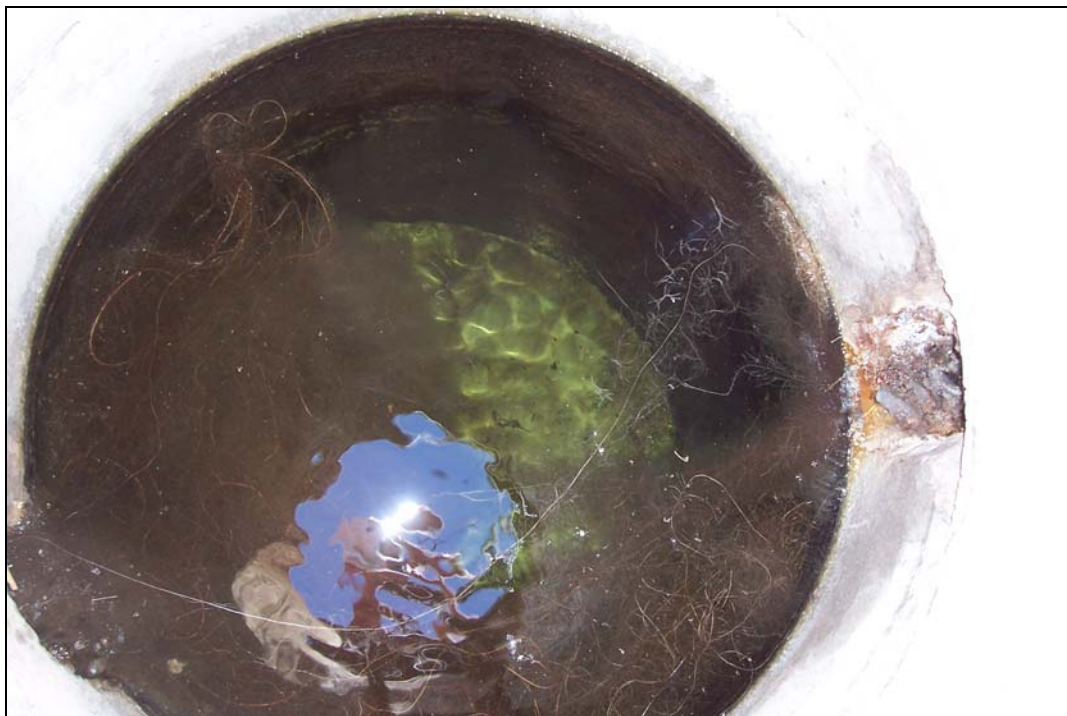
Photo 15: View inside left toe drain manhole. Note standing water and roots within manhole. Toe drain collection pipe flowing at right.

5. Monitor toe drain seepage clarity at the toe drain manhole (rather than sump), including visual observations of water clarity and monthly measurements of turbidity. A contingency plan should also be prepared if high flow rates or increased turbidity are observed in the seepage water.

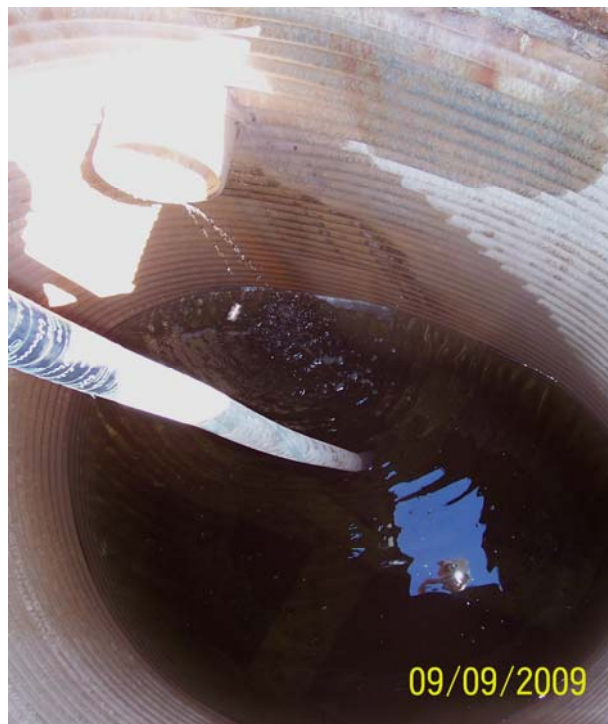
Photo 18: View inside left toe drain sump. Note seepage discharge from inlet pipe, and hanging pipe for pumping collected seepage back to Pond.

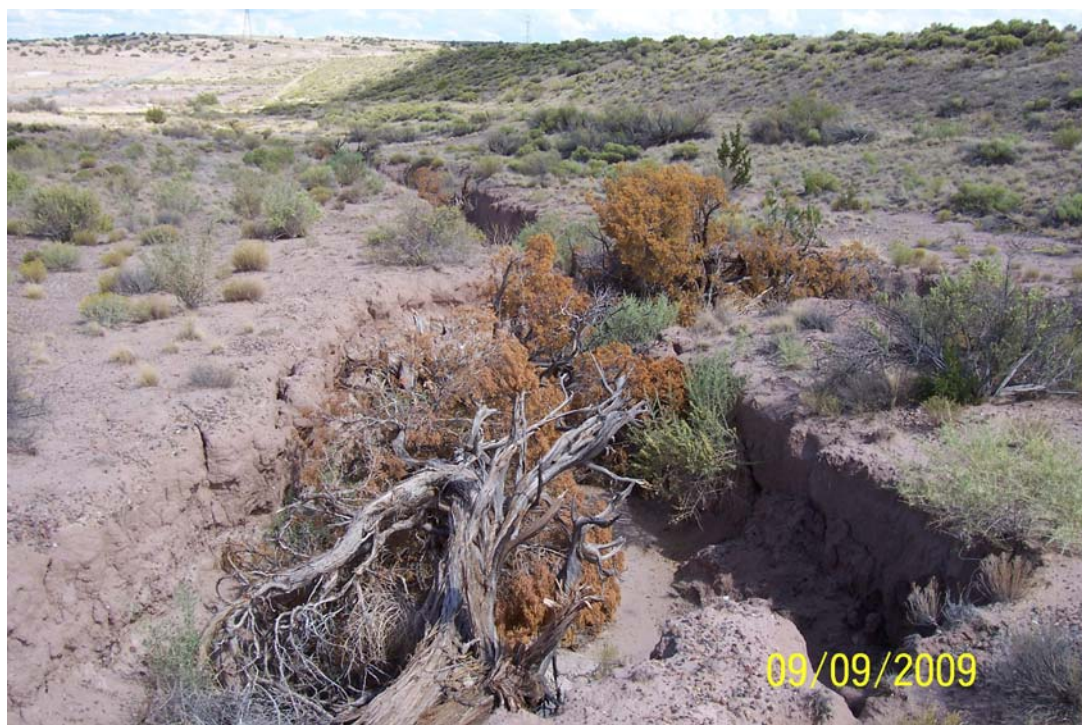
Photo 20: View of erosion gully near left downstream toe of dam. Note woody debris placed in channel by SRP/CGS to control erosion.

1. Repair erosion gullies along the left and right downstream abutment groins, the left upstream abutment groin, and near the downstream toe of the dam at the secondary containment structure. Repair eroded upstream slope at the left abutment and reset any displaced riprap stones. Implement erosion control measures (riprap lining, check dams, vegetative barriers, etc.) to prevent further channel erosion and headcutting.
2. Remove roots from left toe drain manhole and repair any damage from shrub growth and/or root penetration.
3. Repair/replace leaking PVC piping connecting left toe drain manhole to sump. Minimizing leakage from this pipe will help eliminate a potential source of saturated soil in downstream secondary containment area.

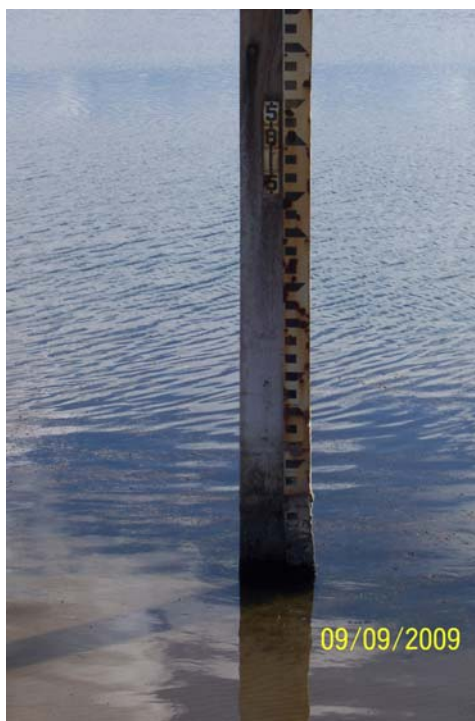
Photo 22: View of staff gage on upstream berm. Note lower markings difficult to read. Pond level at time of inspection was approximately 5810 feet.

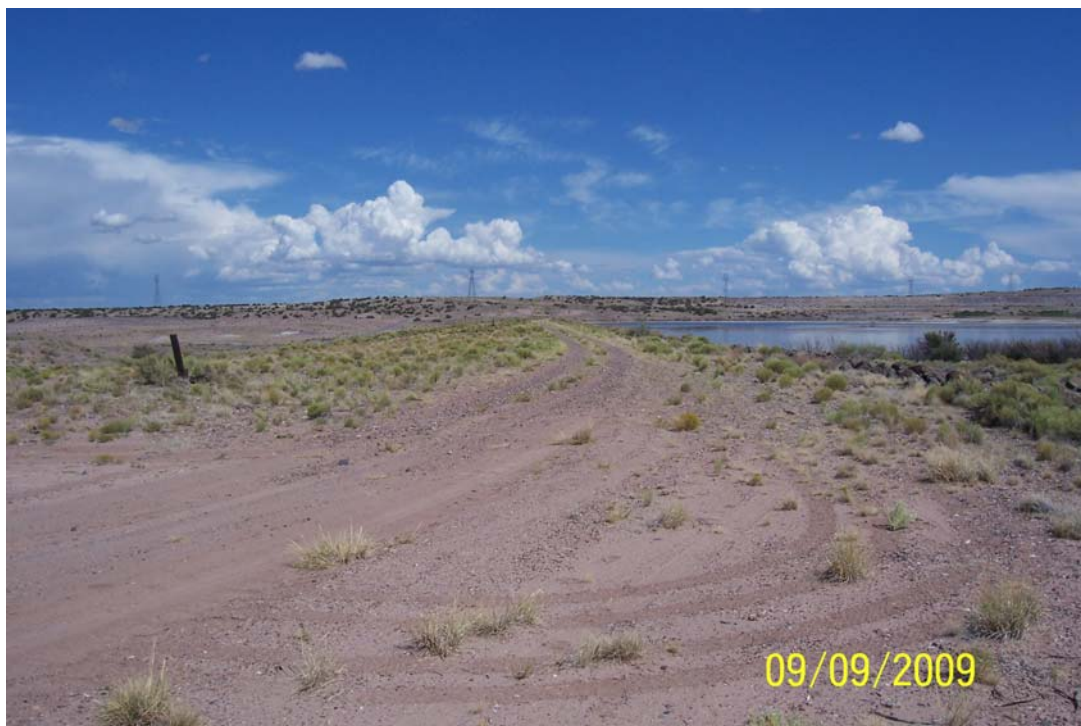
Photo 25: View along top of dam from left abutment. Note minor rutting from vehicle traffic.

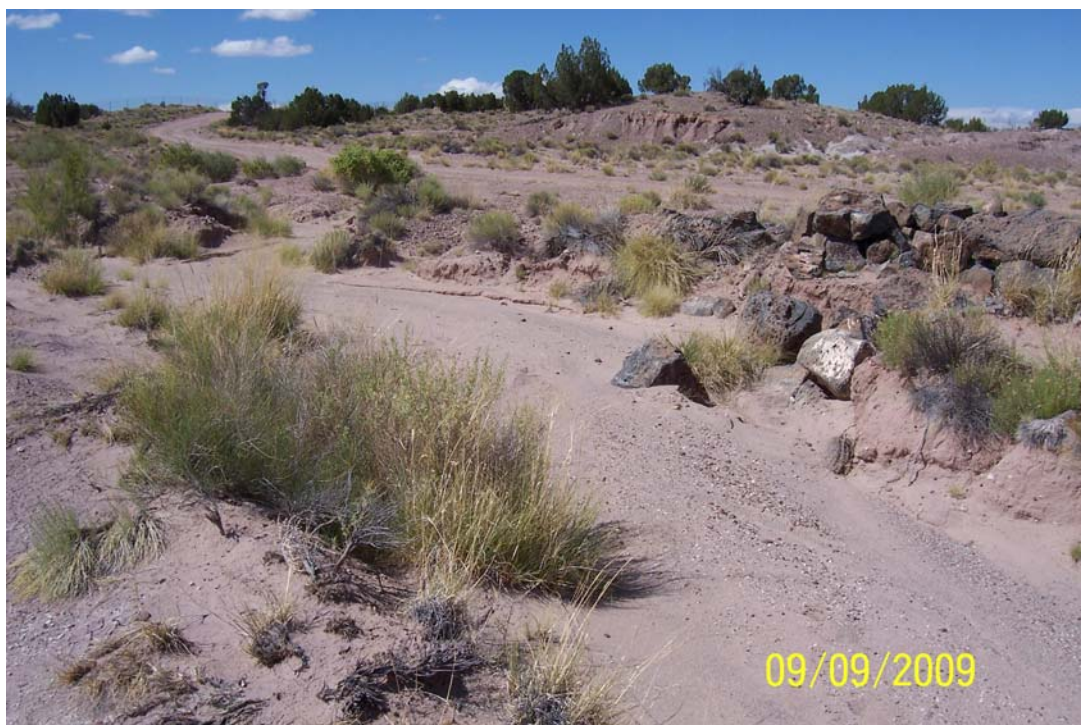
Photo 26: View of erosion channel along left upstream abutment groin. Note undercutting and displacement of riprap slope at right.

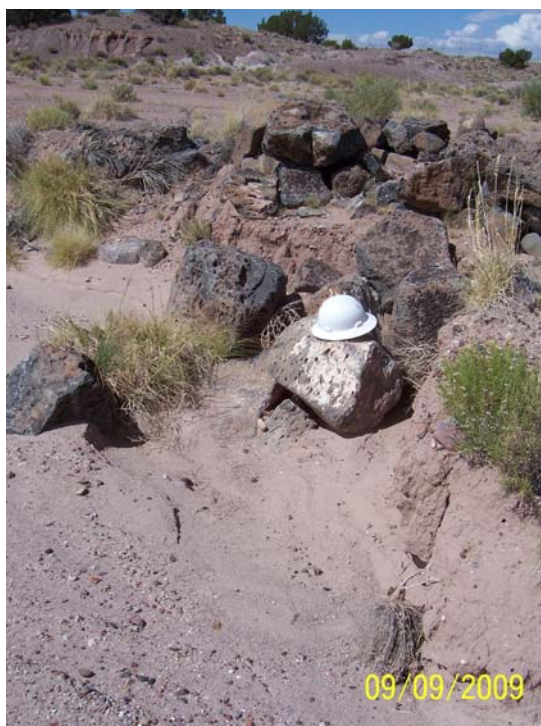
Photo 27: View of undercutting and displacement of riprap at left abutment contact. Hard hat shown for scale.

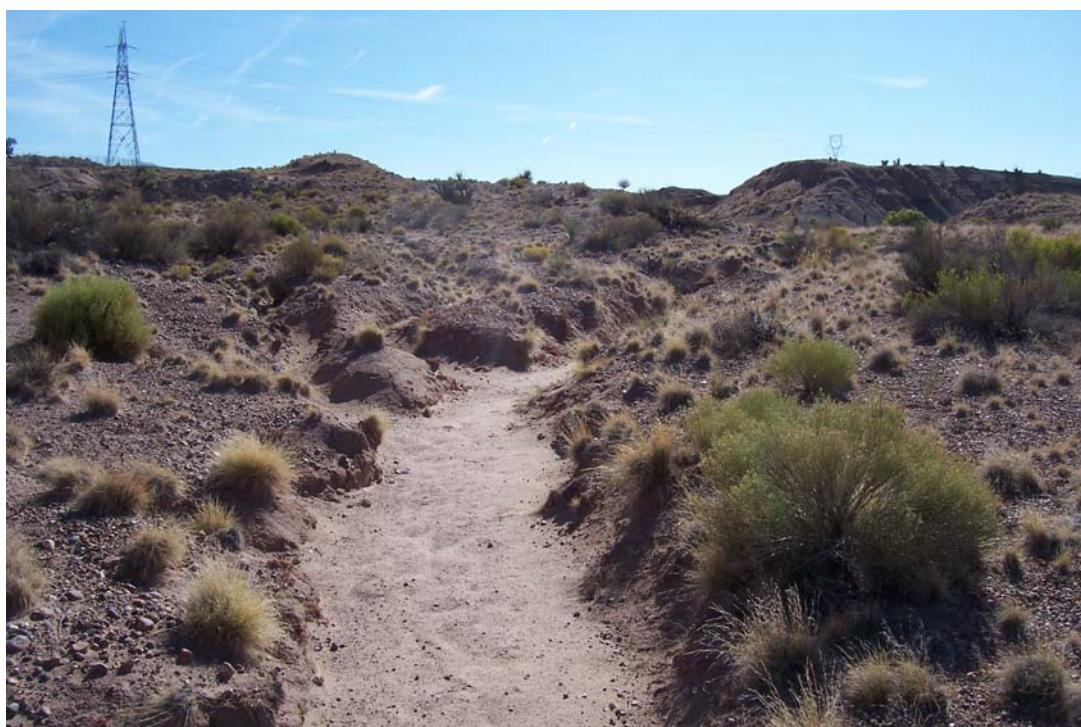
Photo 28: View of erosion channel along right downstream abutment contact.

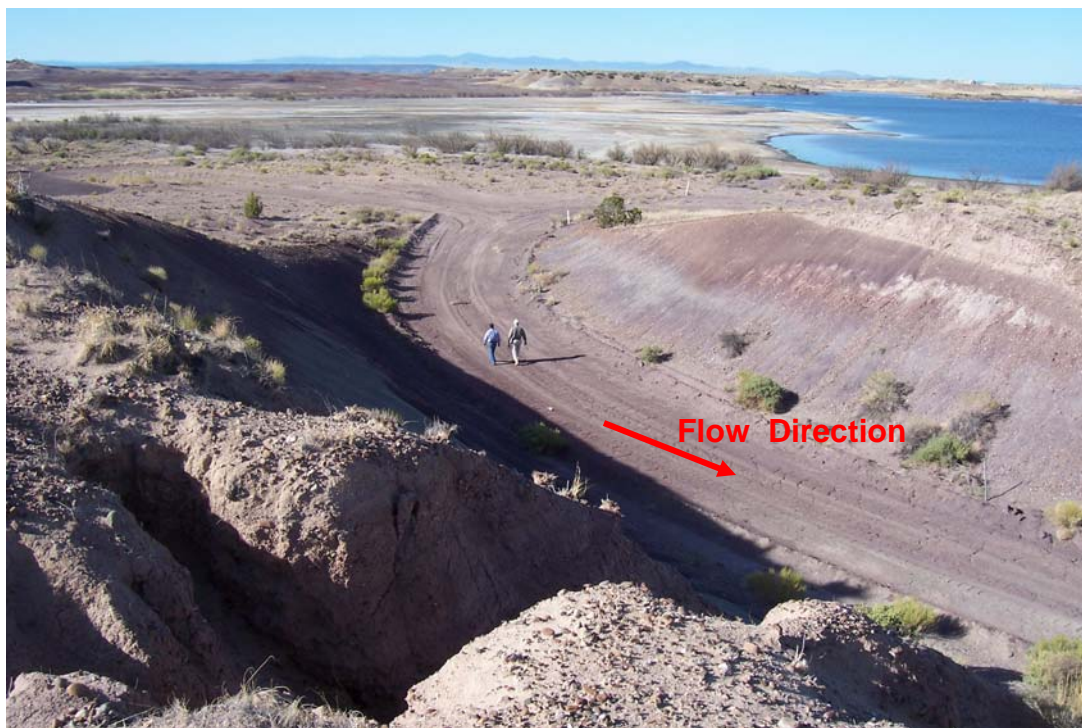
Photo 29: View of emergency spillway approach channel and pond from top of right channel slope. Note slope erosion in foreground.

1. In conjunction with the results of the updated hydrologic and hydraulic analyses, repair the emergency spillway side slopes along the length of the channel. Provide grading and/or other means to direct surface runoff away from the channel slopes, especially along the axis of the dam. Repairs must address the area along the dam axis where a longitudinal crack at the top of the left spillway side slope was observed. Consider improvements, as needed, to stabilize the spillway side slopes and invert control elevation.

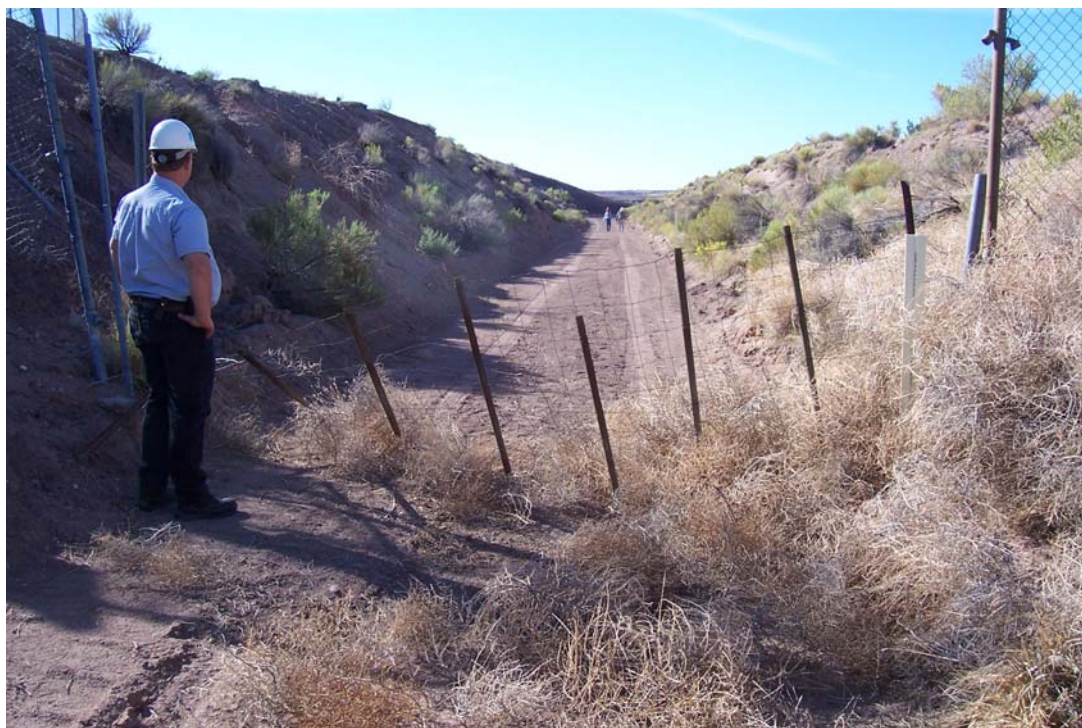
Photo 31: View within emergency spillway channel looking upstream from break-away cattle gate. Note accumulation of tumbleweeds.

4. Monitor left toe drain discharge channel and downstream secondary containment area for presence of wet, soggy soil or unusual vegetative growth.
5. Clear vegetation from emergency spillway approach channel area, and remove sediment as it accumulates.
6. Repair/replace staff gage markers so that Pond water surface elevation can be easily read from the upstream slope of the dam. A distinct marking should be provided at the maximum operating level.
7. Investigate operability of the meteorological instruments on top of the dam. Remove instruments if inoperable.

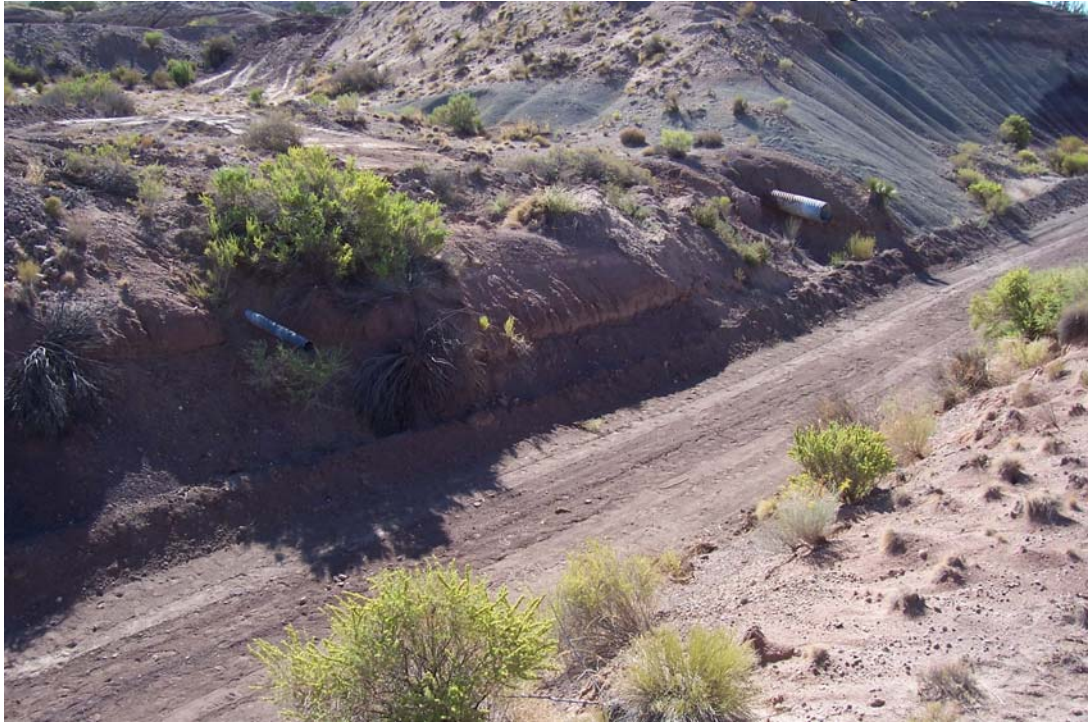
Photo 35: View of emergency spillway near channel control section. Note eroded channel slope. Surface crack observed at top of left slope (see following photos).

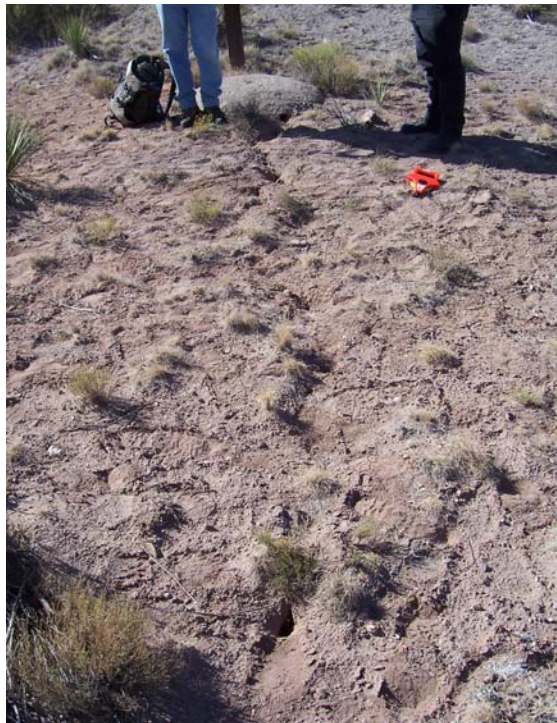
Photo 36: View of surface crack near top of left slope of emergency spillway channel, near control section of channel and axis of dam.

2. Evaluate the surface crack on top of the left slope of the emergency spillway channel (along the dam axis by surface settlement monument #10). Monitor the surface crack for signs of additional movement or enlargement.

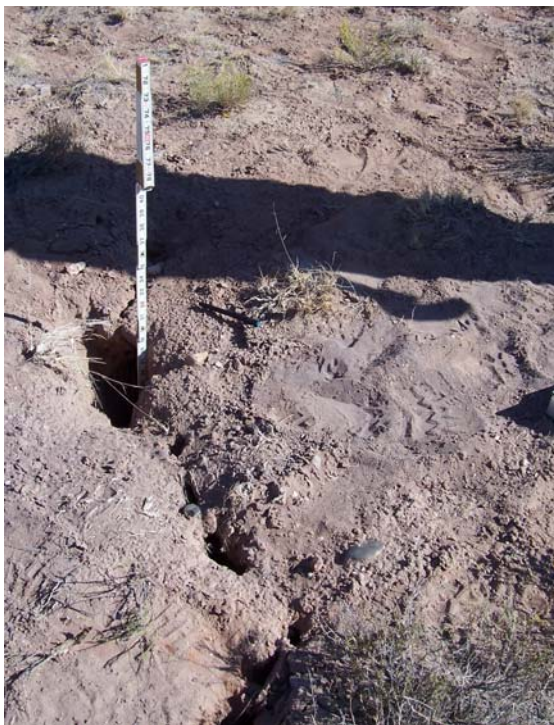
Photo 37: Detail view of surface crack near top of left slope of emergency spillway channel. Note ruler inserted approximately 30 inches into crack.

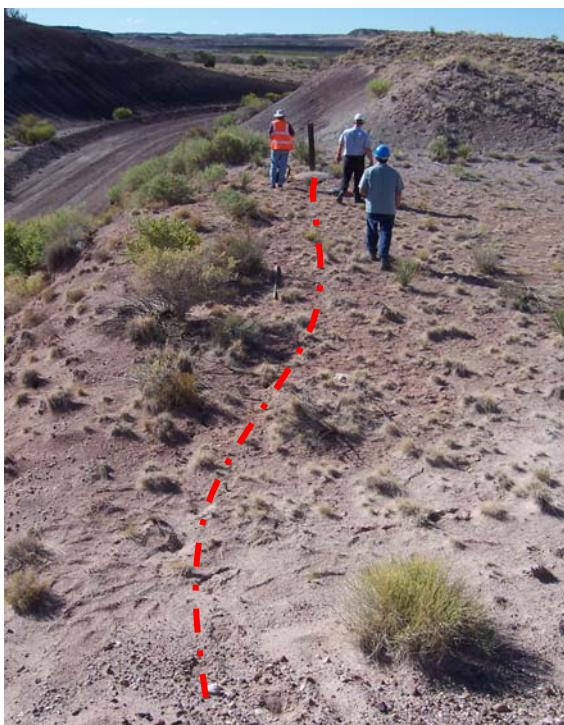
Photo 38: Overview of top of slope area where surface crack was observed. Approximate alignment of surface crack shown with dashed line.

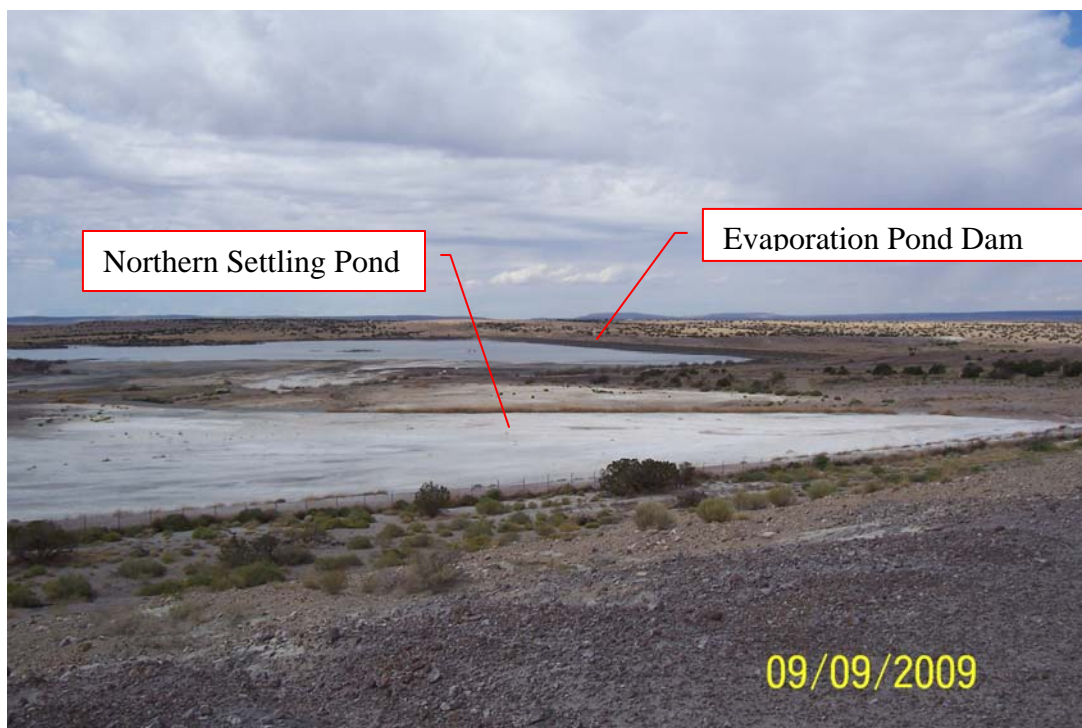
Photo 39: View from Ash Landfill area towards settling pond and Evaporation Pond Dam. Note small earthen berm around northern settling pond.

7. Collect/develop documentation of the “As-Built” configuration of the two settling pond embankments and appurtenant structures.
8. Investigate the potential impacts of an embankment failure of the two settling pond embankments, including an evaluation of the resulting flood wave impact to the Evaporation Pond Dam.
